Consumer Product Service
Manager of Tehnical Support
TECH TIP

VCS
number 7

MODEL: CX5200

Defective Rockwell 6502 MPU on CX5200 PC Board.

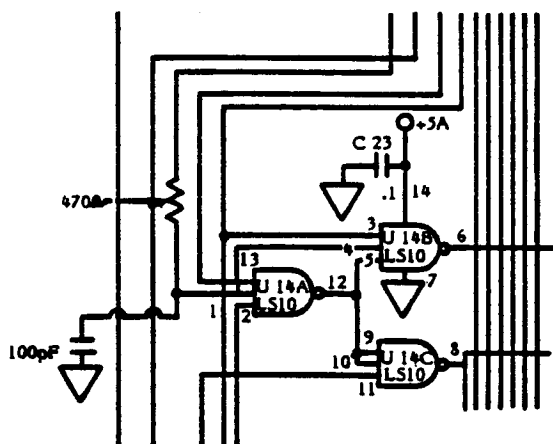
Figure 1. CX5200 Schematic (R-C Network)

Rockwell MPUs with date code of 8250 and later (stamped with the letters RC) have a timing defect.

A factory modification adds an R-C network on the component side of the CX5200 PC Board at IC U14A (pin 1) and U6A (pin 4) (see Figures 1 and 2).

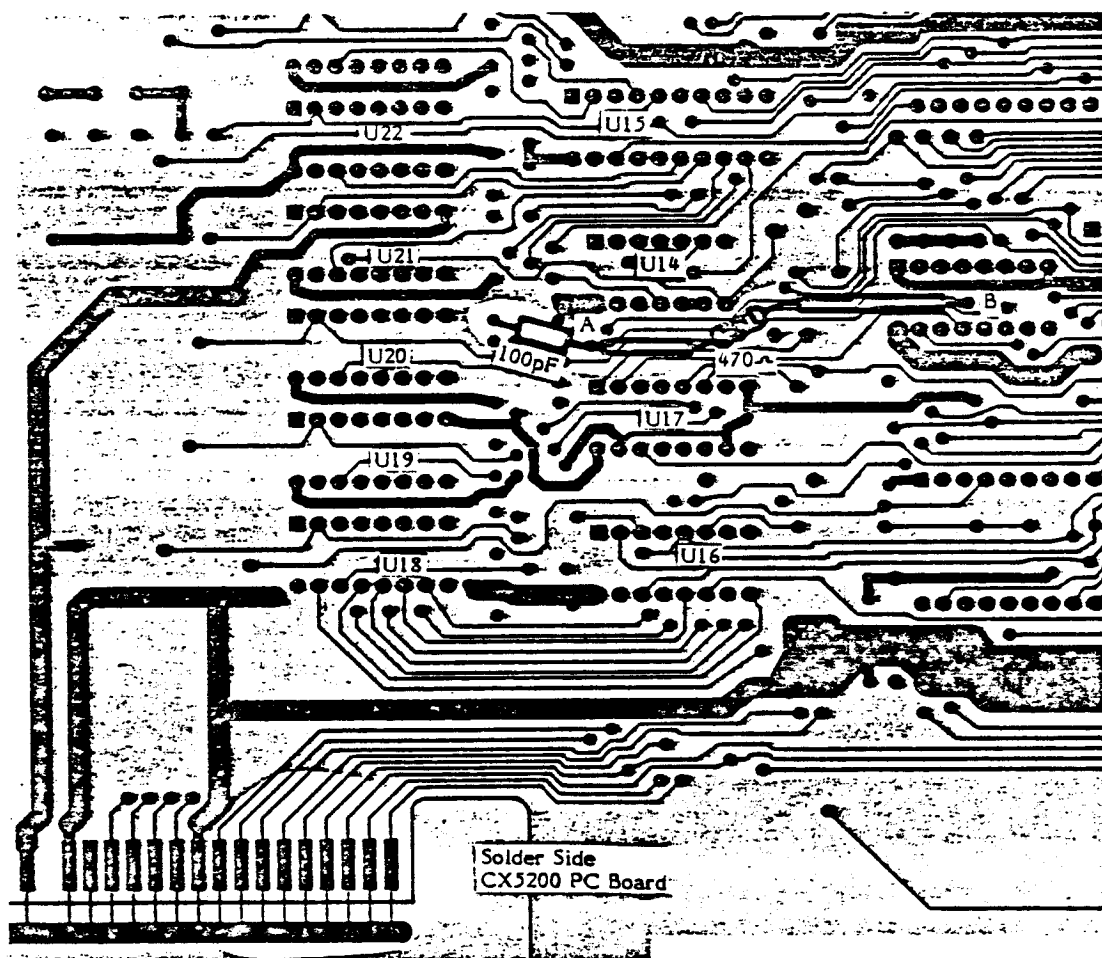
Figure 3. R-C Network (Add to solder side of CX 5200 PC Board)

If you are installing an RC stamped 6502 on a CX5200 PC Board which has not had the factory modification added to the component side:

Add an R-C network to the solder side of the PC Board (See Figure 3).

See Figure 3 for the following steps:

1. Straighten the lead of C27 (solder side) and solder one lead of the 100 pf capacitor to it.
2. Point A is an unoccupied well between IC's U14 and U17. It is connected directly to Pin 1 of U14. Cut the trace running between points A and B as close to Point A as possible. Use a DVM to insure that the trace is now open.
3. Add sleeving to one lead of the 470 Ω resistor. Insert the lead into the well at Point A and solder.
4. Wrap the remaining lead of the 100 pf capacitor around the lead of the 470 Ω resistor at Point A and solder.
5. Remove the solder from well at Point B which is directly beneath U6. Add sleeving to the remaining lead of the 470 Ω resistor. Insert this lead into the hole at Point B and solder.
